LAKE TIMBERLINE DAM

NDI No. PA00977
PennDER No. 58-125
Dam Owner: Richard O'Reilly

PHASE I INSPECTION REPORT
NATIONAL DAM INSPECTION PROGRAM
PACW 31-81-C-001

Lake Timberline Dam, Susquehanna County, Pennsylvania
NDI No. PA 00977, PennDER No. 58-125
Tributary of Choconut Creek
Inspected 30 March 1981

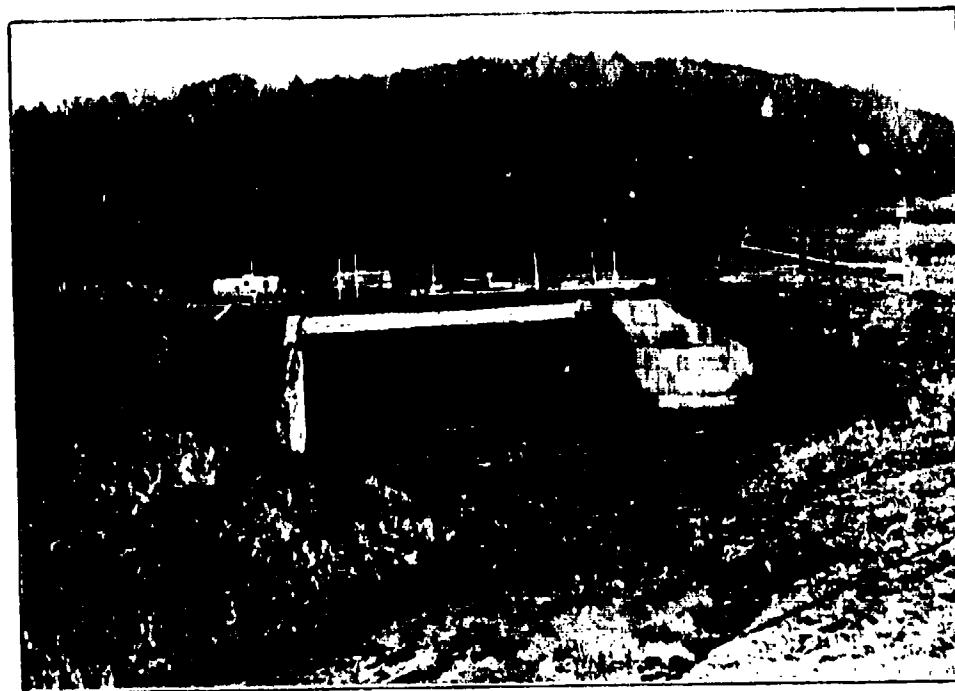
- b. Embankment - Erosion was observed around both downstream ends of the spillway training walls. Minor erosion was also noted along the upstream face of the embankment at normal pool level. Brush and some small trees are growing on the downstream face of the embankment. Clear seepage (approximately 1 g.p.m.) was flowing from the toe of the embankment near the outlet pipe. The embankment slopes appeared to be approximately 2H:1V with the slopes near the outlet pipe appearing to be 1H:1V.

PHOTO 3. View of Downstream Side of Spillway

- 1) Provide adequate spillway capacity.
- 2) Fill and seed the eroded areas at the downstream ends of the spillway training walls.
- 3) Place riprap above and below normal pool level on the upstream slope of the embankment.
- 4) Monitor the seep near the outlet pipe at regular intervals and during periods of high reservoir levels for turbidity and/or increase in flow, which may indicate potential for the piping of embankment material. If turbidity and/or increased flows are noted, a qualified
